Parcela (1D) Intrarea Fluturilor

| SPECIFICAȚIE | NUME | SEMNĂTURA | Scara | PLAN DE SITUAȚIE<br>INTRAREA FLUTURILOR<br>Număr cadastral 10827<br>Sat Pădurișu, comuna Frumușani,<br>județul Călărași | | Planșa nr.<br>1 |

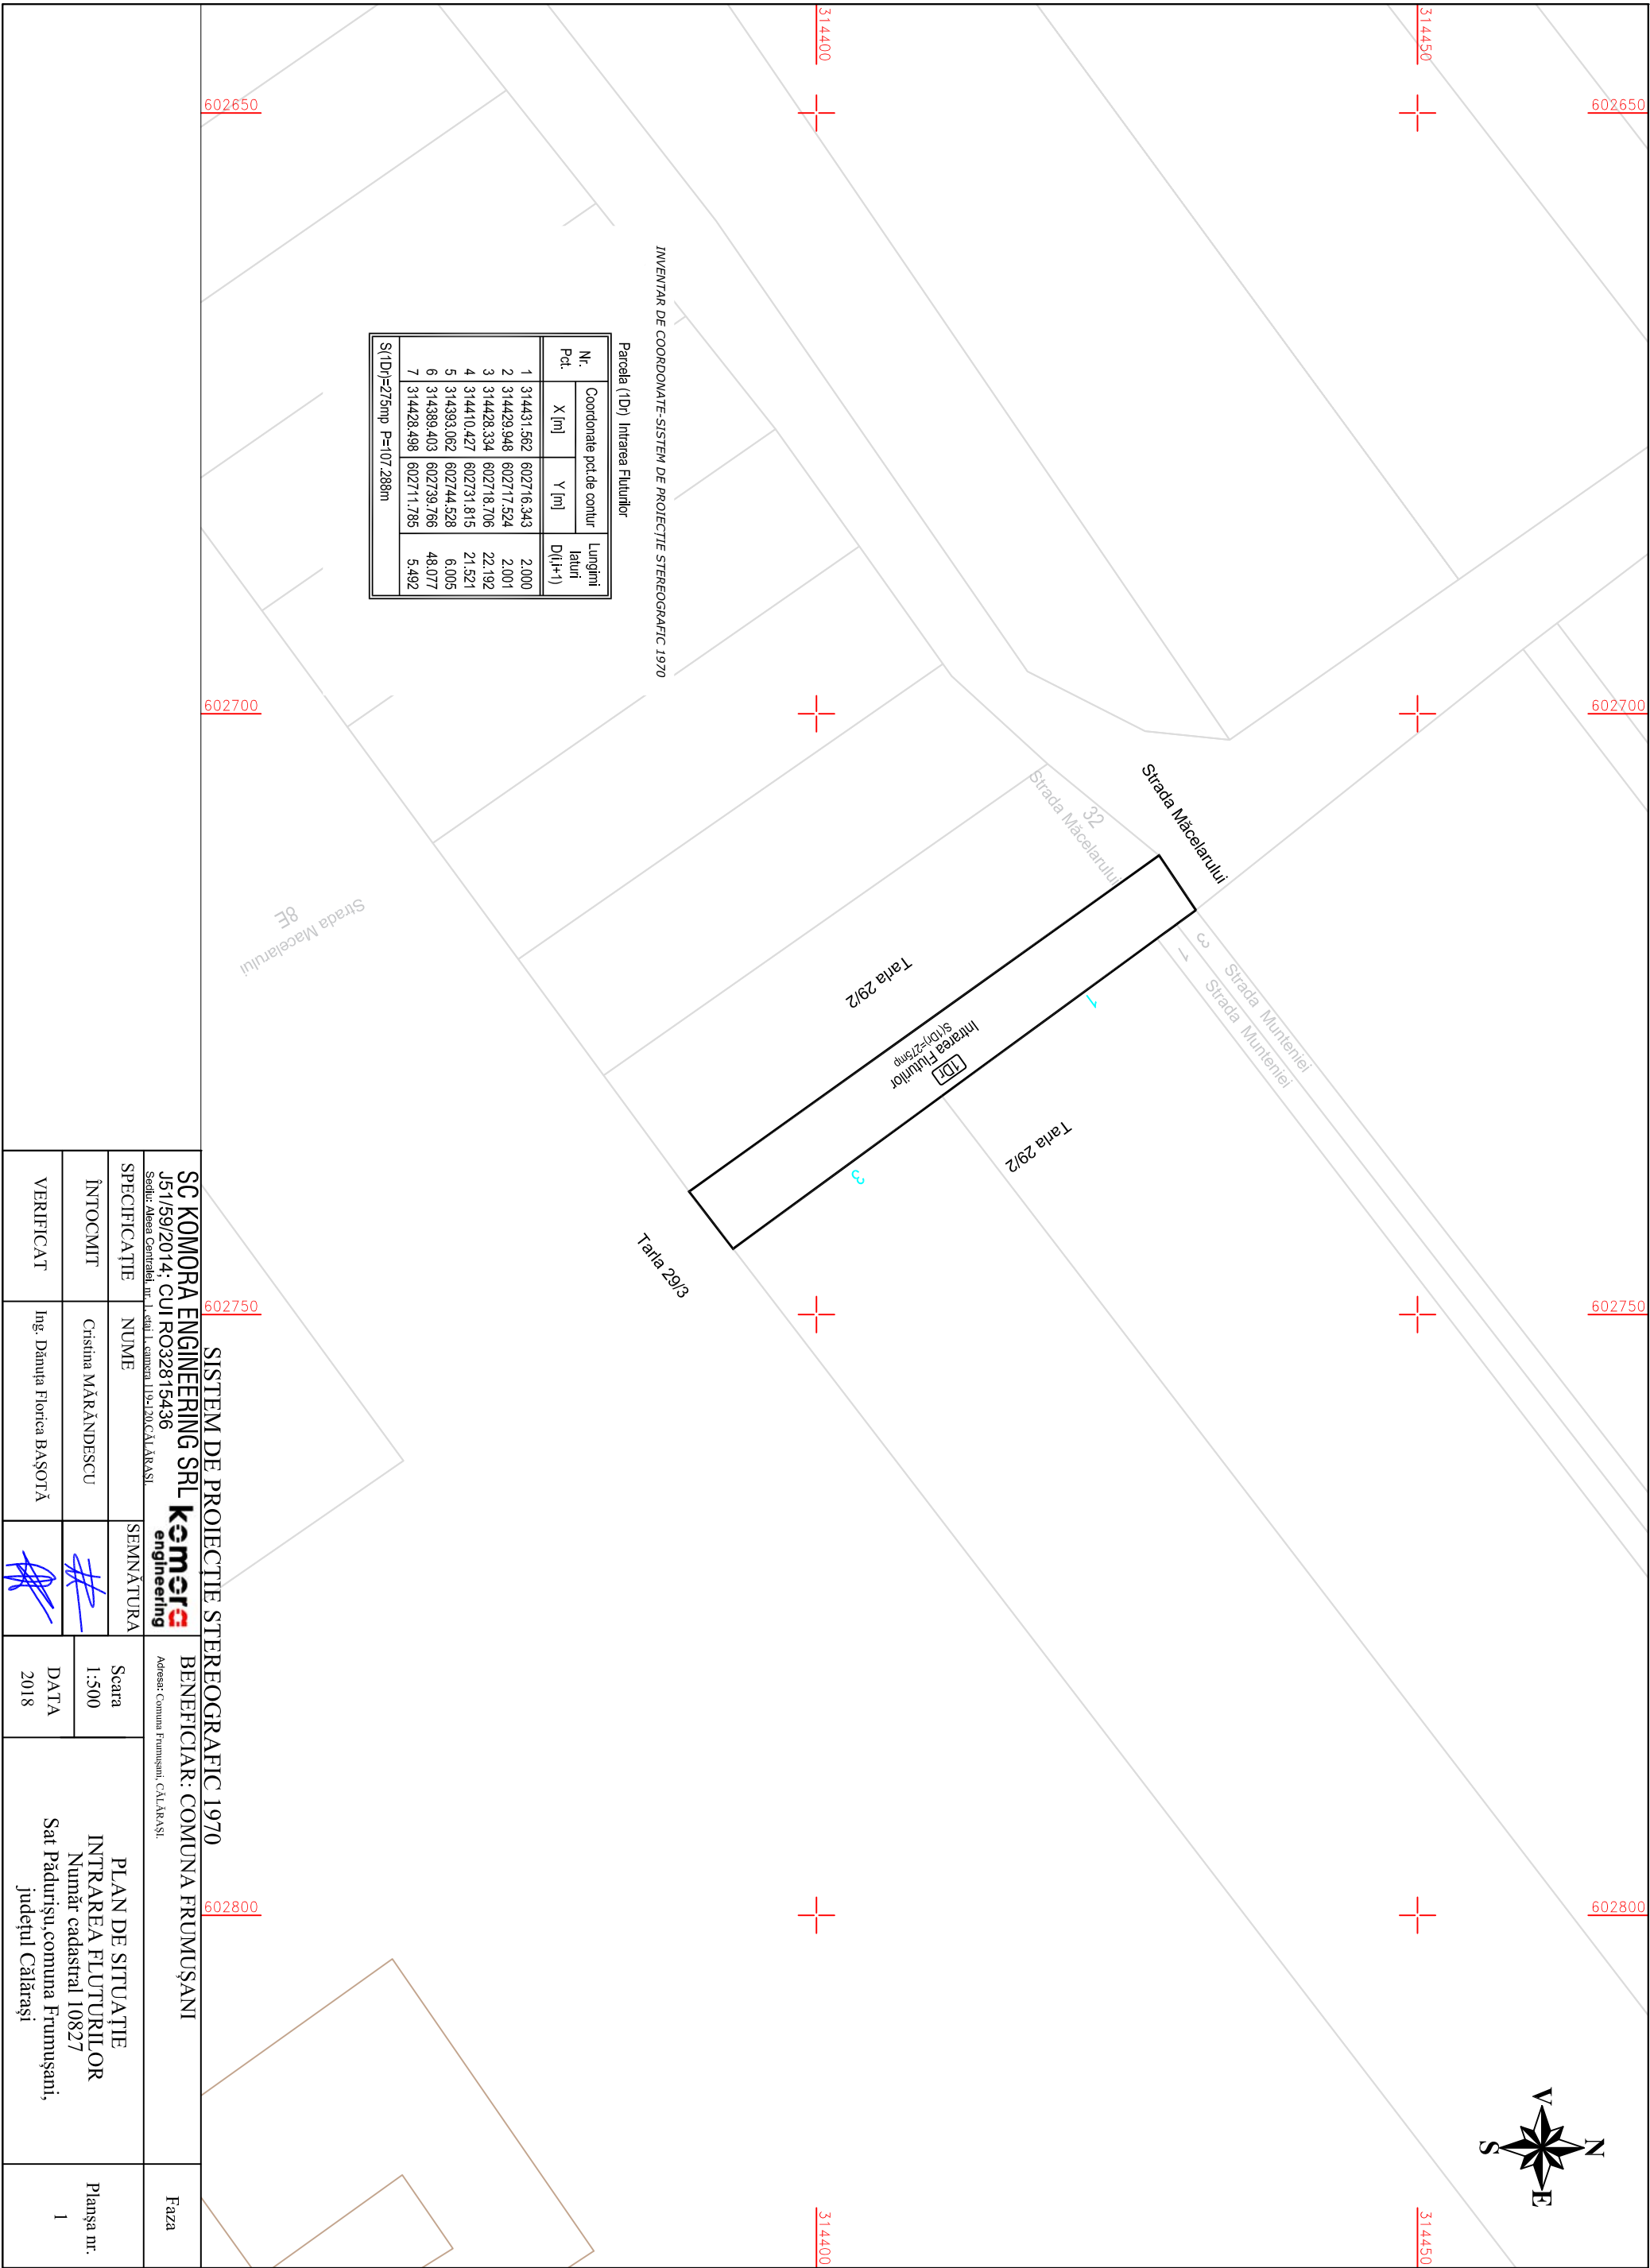
INVENTAR DE COORDONATE-SISTEM DE PROIECTIE STEREOGRAFIC 1970

SI(1D)=275mp P=107.288m
